Hazards from Surface Faulting in Earthquakes

KOBAYASHI, Yoshimasa

KOBAYASHI, Yoshimasa. Hazards from Surface Faulting in Earthquakes. Bulletin of the Disaster Prevention Research Institute 1976, 26(4): 213-240

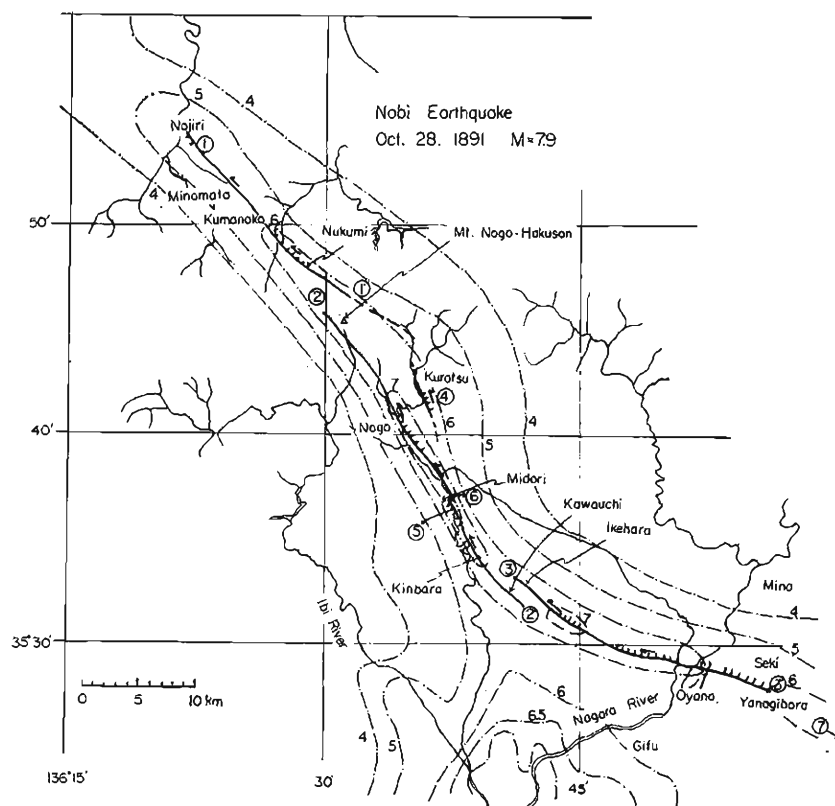
Fig. 1. Faults and earthquake intensities in the Nobi earthquake; ①; Nukumi fault, ②; Neodani fault, ③; Umehara fault, ④; Kurotsu fault, ⑤; Midori fault, ⑥; Midori-Daishogun fault, and ⑦; Koze fault. (compiled after Matsuda and Muramatsu)

Nobi Earthquake in 1891; Faulting in the Nobi earthquake is described by Matsuda⁵⁾ in detail. The main fault segments from north to south are the Nukumi fault of about 20 km from Nojiri to the Nukumi pass, the Neodani fault of about 35 km from the south of Mt. Hakusan to the east of Kawauchi, and the Umehara fault of about 25 km from the north of Ikehara to Yanagibora, which formed an aggregated main fault system of about 80 km long with a trend of NW-SE. Besides the above, several faults of shorter extension as the Kurotsu, Midori, Midori-Daishogun, and Koze faults exist (Fig. 1).

In Fig. 1 it may be noted at once that the three main fault segments do not constitute a simply connected line, but there are gaps of about 3 km and 1.5 km between the ends of the Nukumi fault, the Neodani fault, and the Umehara fault in turn, and also that the mean strike of the main fault line changes from N45°W in the northern part to N60°W in the southeastern Umehara fault. Nasu⁶⁾ estimated a hidden, i.e. sub-surface fault named Line C based on the result of levelling at triangular points. Muramatsu⁷⁾ also suggests a concealed fault line from Kinbara through north Gifu and Ichinomiya to Nagoya on the basis of data of seismic intensity and crustal deformation, which line deflects to some extent eastward from the line C.

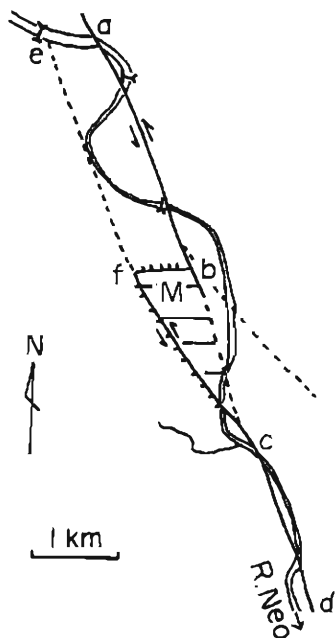
Fig. 2. Triangular bulge at Midori due to left-lateral movement on the main fault in the Nobi earthquake; a-b-c-d; Neodani fault, e-f-c; Midori fault, and b-f; Midori-Daishogun fault. (illustrated after Matsuda)

the Midori fault with 4.0 m(H), where in contrast to cases in most of the main fault segments the NE side was uplifted. This peculiar phenomenon may be attributed to a bulging due to compression accompanying the left lateral shear of a triangular block bounded by the Midori fault (N40W), the Midori-Daishogun fault (nearly EW) and the main fault of Neodani⁵⁾ (Fig. 2).

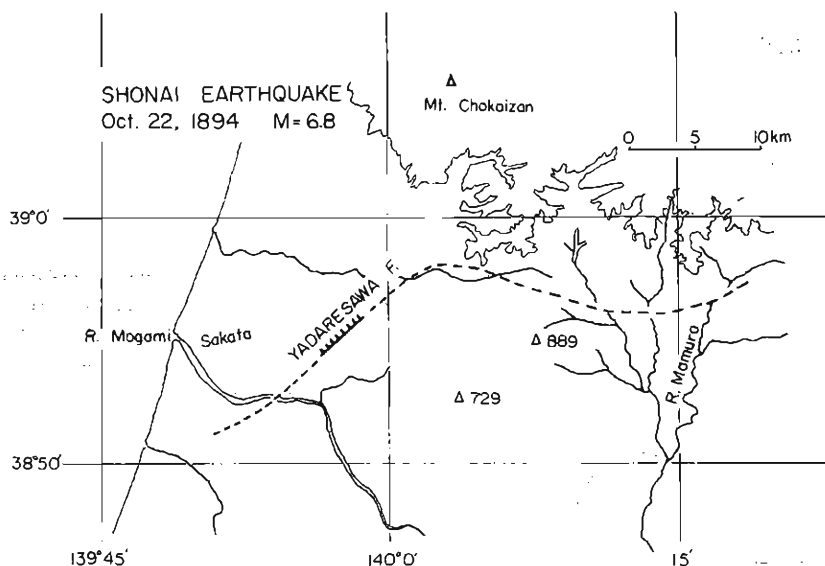
Fig. 3. Faulting in the Shonai earthquake. The broken line is postulated.

The above concealed part to the west and the postulated part for the more easterly region than Aosawa on the basis of a report on the damage by Sugaya are drawn in broken line in Fig. 3. In Table 1 the length of the Yadaresawa fault is given as 10 km, which corresponds to the part from Nibori to Kita-Aosawa. In conclusion it seems to be doubtful if faulting actually occurred in the Shonai earthquake, or at least it must be stated that not much is known so far on the faulting in this earthquake in view of available materials.

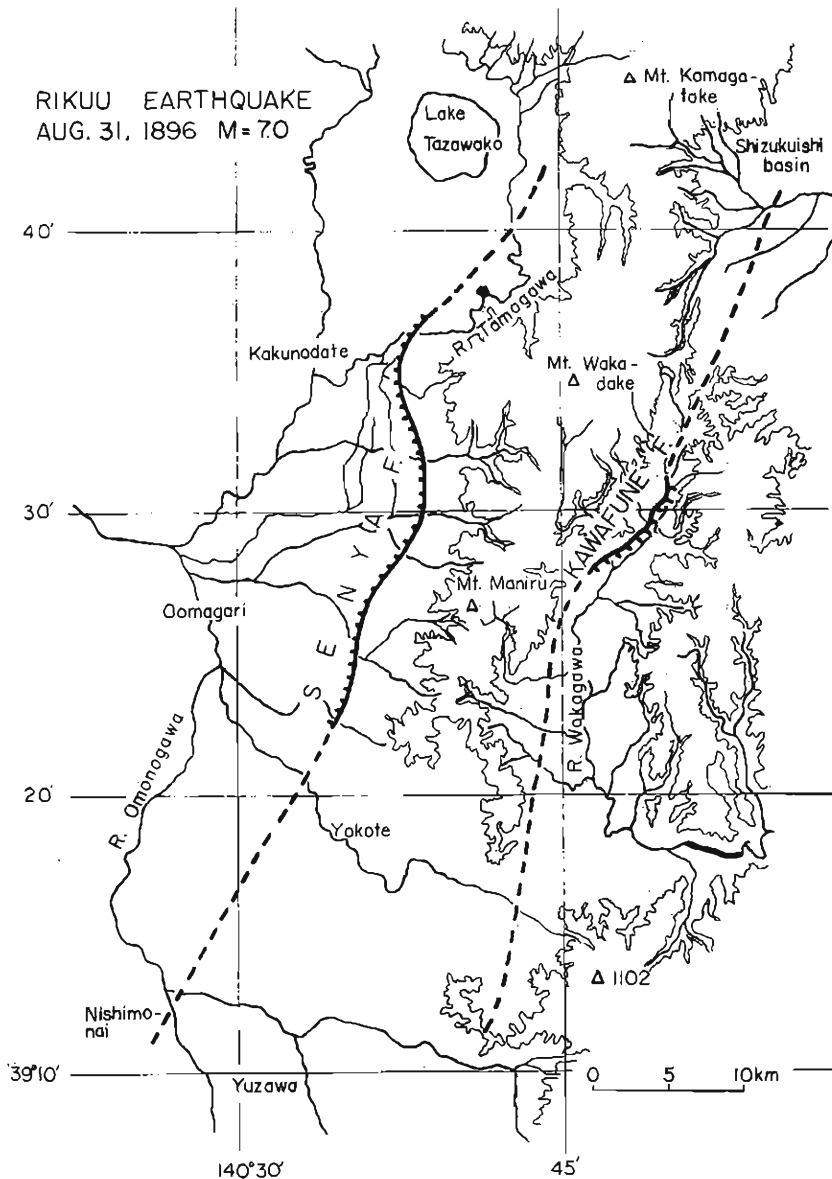
Fig. 4. Faults in the Rikuu earthquake.

Rikuu Earthquake in 1896; Two nearly parallel faults were formed in the earthquake; the Kawafune fault and the Senya fault (Fig. 4). The former is a reverse fault with its west side uplifted which was formed along the Wakadani valley on the east side of the Mahiru mountain ridge of NS trend. At the northern end of the fault, Ôaresawa in the Wakadani valley, it exhibited a vertical offset of 2 m, and extended southward through Wakahata, Yatsumata, Kôge, Kawafune, where also the west sides were uplifted by the order of 1 to 2 m, and further somewhat indistinctly toward the west of Ôta reaching about 15 km in total length. It is interesting to note the manner of faulting at Kawafune, where a road was crossed by the fault

lated parts are given in broken line in Fig. 4.

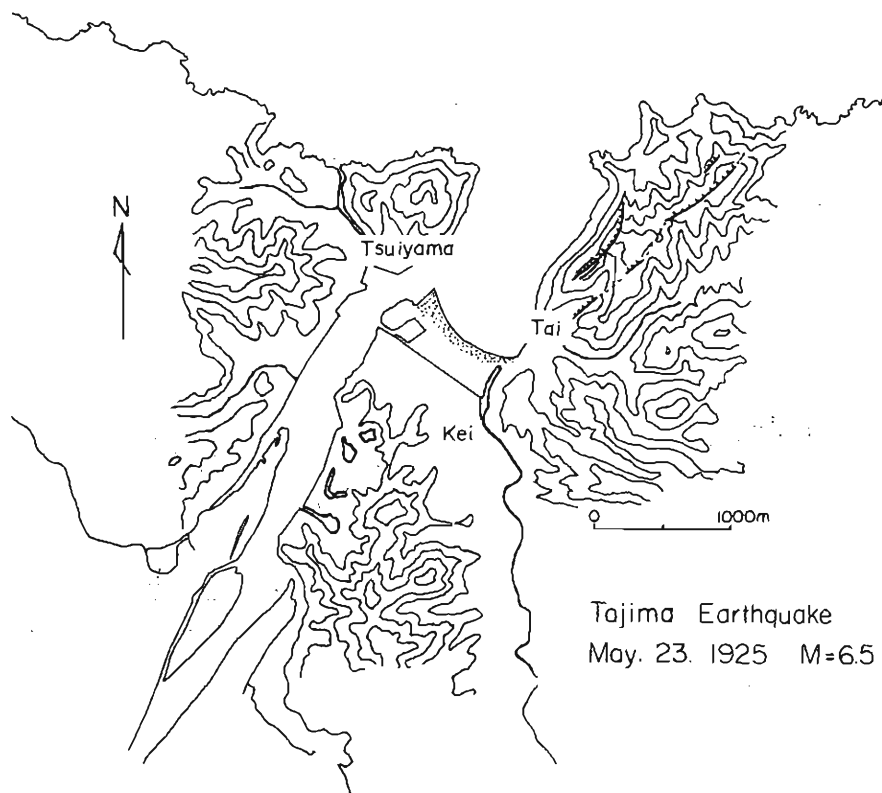
Fig. 7. Faults in the Tajima earthquake.

Tajima Earthquake in 1925; Two faults parallel to each other, the Tai West as well as Tai-East faults, were formed (Fig. 7)¹⁴. The former was 0.7 km long and the latter about 1.6 km long, and the distance between them was 400 m. The Tai-West fault ran from the cliff facing the Tsuiyama bay towards NW, with several fissures. It appeared on the mountain as a concentration of some ten fissures, which formed as a whole a graben-like depressed zone. The west side of the fault was subsided, however some fissures exhibited hinge-fault movement. The East fault

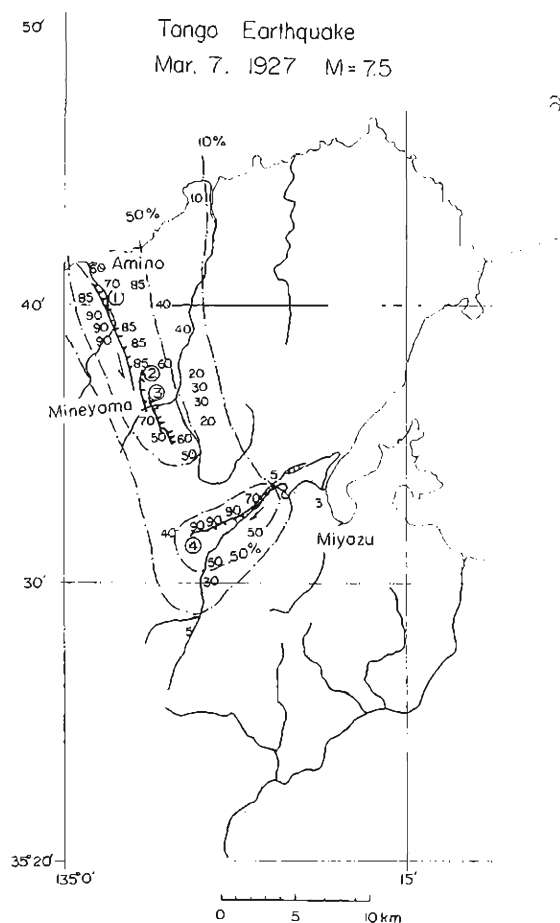
Fig. 8. Faults and percentages of totally collapsed houses in the Tango earthquake; ①; Takahashi fault, ②; Nimbari fault, ③; Nagaoka fault, above three together named the Gomura fault, and ④; Yamada fault.

Tango Earthquake in 1927; The Tango earthquake is characterized by a pair of very peculiar conjugate faults called the Gomura fault and the Yamada fault¹⁵⁾. The former crossed the Tango Peninsula from NW to SE, and the latter ran along the southern coast of the Peninsula from SW to NE composing a conjugate pair with the former (Fig. 8).

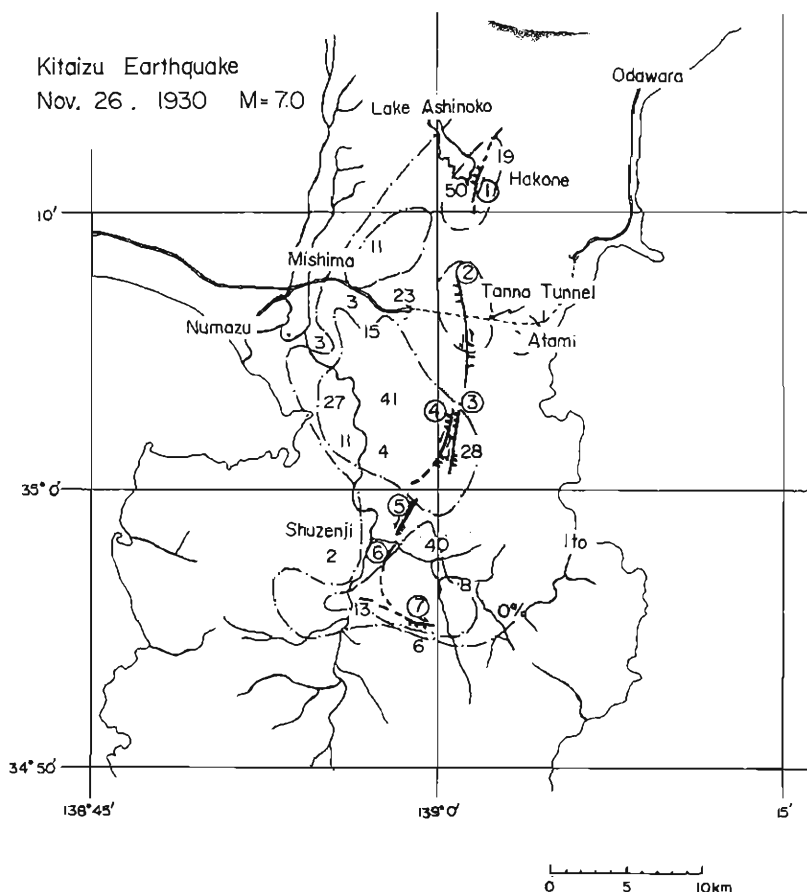
Fig. 9. Faults and percentages of totally collapsed houses in the Kitaizu earthquake; ①; Hakonemachi fault, ②; Tanna fault, ③; Ukihashi-Central fault, ④; Ukihashi-West fault, ⑤; Ōno fault, ⑥; Kadono fault, and ⑦; Himenoyu fault.

etc. are the latter (Fig. 9). Each fault constituting the main fault system is formed in échelon arrangement with gaps between each end of 1 to 5 km in the direction of strike and 1 to 2 km in the direction perpendicular to the strike. The amounts of offset across faults were 0.3 to 3.5 m in horizontal and 0.2 to 2.4 m in vertical direction. In contrast to a consistent sense of slip in horizontal component the vertical ones at faults of NS trend were variable, and especially the Tanna, both Ukihashi, Ōno, and Kadono faults proved to be hinge faults, i.e. the east sides were uplifted in the northern parts and the west sides in the southern parts, while the movements were consistently left lateral in the horizontal component. According to Kuno¹⁷⁾ the west side should be uplifted in the southern part and its extension of the Tanna fault, but it was not very distinct in this earthquake. In Karuizawa in the Tanna Basin the drying up of wells and a strange phenomenon, where radishes were thrown out of soil are reported¹⁸⁾. The Tanna tunnel, JNR, under construction suffered damage

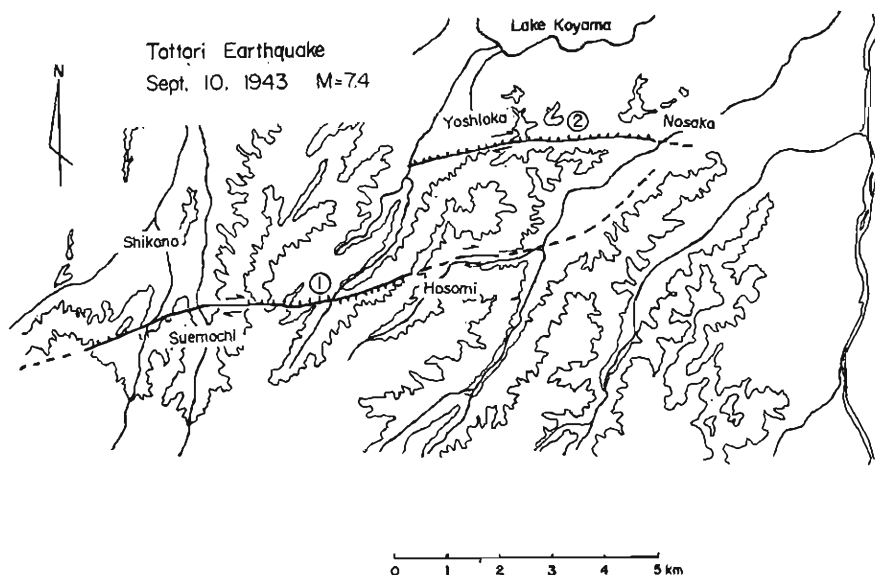
Fig. 10. Faults in the Tottori earthquake; ①; Shikano fault, and ②; Yoshioka fault.

The positions of the two faults are en échelon, and it cannot be determined which may be the main or the secondary, since they have comparative lengths and displacements. The normal distance between the both faults is about 2 km, however it is also possible that they join together underground near Nosaka (See Fig. 10).

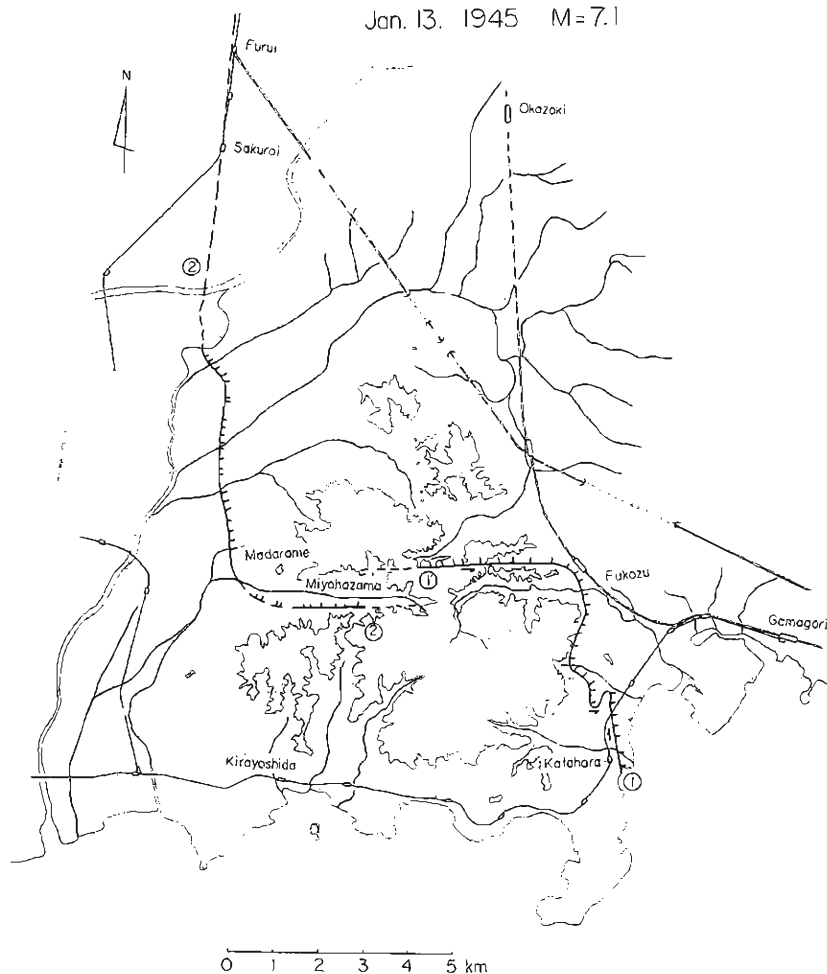
Fig. 11. Faults in the Mikawa earthquake; ①; Fukoju fault, and ②; Yokosuka fault.

Mikawa Earthquake in 1945; Two very peculiar faults were formed in this earthquake, i.e. the Katahara fault or the Fukôzu fault and the Yokosuka fault (Fig. 11). The former has been described by Tsuya²¹ in detail. It starts at the right bank of the Otowagawa river in Katahara town toward north, bends to west at Maeno and extends as long as about 500 m, turns there NNW and goes 2.75 km as far as Fukôzu, and there again turns to the West and proceeds along the Sakagawa river on the north

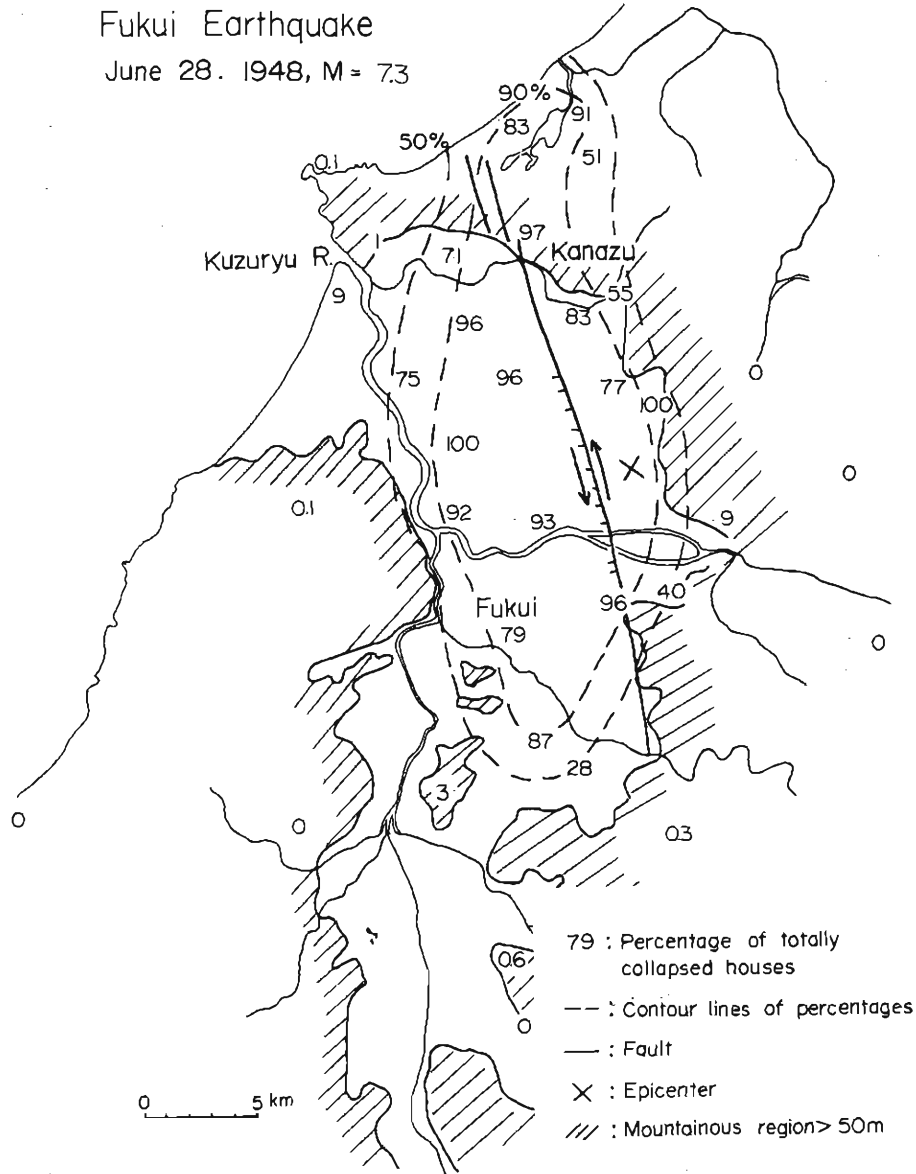
Fig. 12. The underground fault and percentages of totally collapsed houses in the Fukui earthquake.

Fukui Earthquake in 1948; Faulting in the Fukui earthquake was not a surface faulting in a proper sense, but it was presumed through data of levelling and triangulation (Fig. 12)²⁴). Soon after the earthquake the measurements were carried out and an upheaval and northward displacement of the eastern half of the Fukui plain as well as a subsidence and southward displacement of the western half were detected. The maximum dislocation were estimated as 70 cm in vertical and 230 cm in horizontal. The boundary between the uplifted and subsided regions ran N20°W–S20°E. The total length of the fault amounted to about 25 km and its northern end reached the coast of the Japan Sea. Numerous fissures and cracks were observed on the ground surface above the fault line, however the main fault rupture itself remained

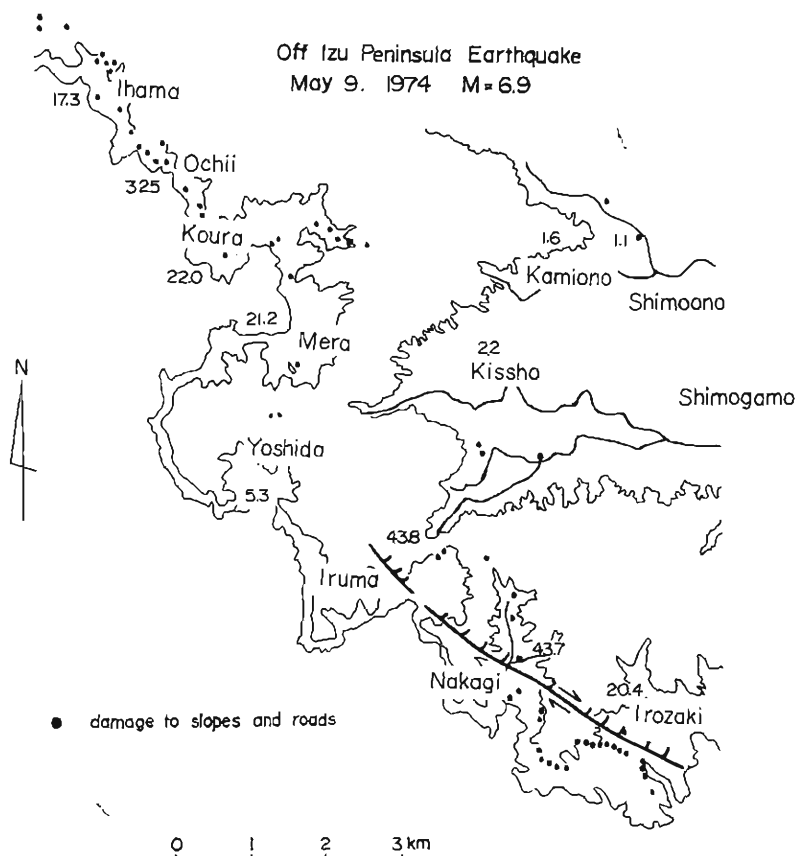
Fig. 13. Faulting in the off Izu-Peninsula earthquake and distribution of damage to slopes and roads.

Off Izu Peninsula Earthquake, 1974; In the earthquake of M 6.9 an evident right-lateral fault named Irôzaki-Central fault was formed traversing Irôzaki with a strike of NW-SE (Fig. 13). The fault appeared as a clear cut with an offset of 35 cm in horizontal and 17 cm in vertical at an andesitic rock cliff at the east end of the town. It traversed that locality forming en échelon fissuring, which caused breakage of many foundations of houses, crossed a road causing a slope failure, and extended toward NW in the mountainous region. It seems to have passed marginally the mountain side of the road connecting Irôzaki with other western sites at the point above Nakagi, destroying a tunnel on the road. After crossing this road at NW of the tunnel the fault extended further toward NW and became indistinct in the mountains.

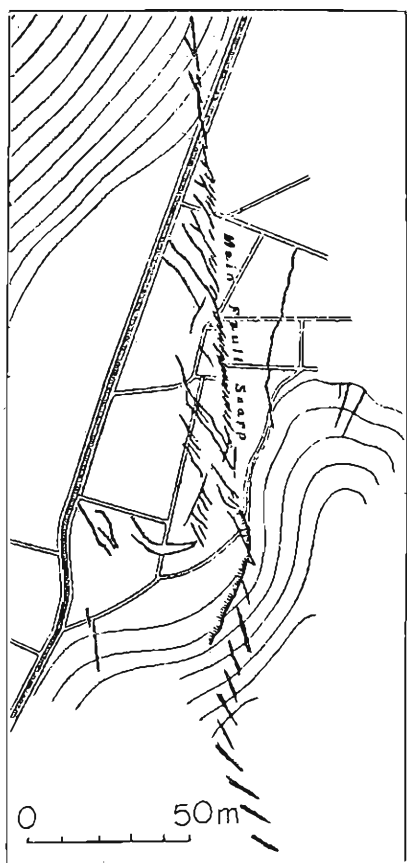
Fig. 14. Cracks en échelon along the left-lateral Gomura fault in the Tango earthquake. (reproduced from Yamasaki)

In soft soil areas cracks en échelon are observed very often (Fig. 14). This type of crack has been experienced in the Tango, Tottori, Mikawa, and the Izu-Peninsula earthquakes. They occur mostly in soft sediments and sometimes also in soft rocks.

In the Tango earthquake a series of cracks en échelon as shown in Fig. 14, were formed along the left-lateral Gomura fault. It is evident that these cracks were caused by tensile stress due to shear. In the Tottori earthquake also a series of cracks with strikes $N50^{\circ}$ – 80° W were observed along the right-lateral Shikano fault in the EW direction, which also suggests the same cause of these cracks.

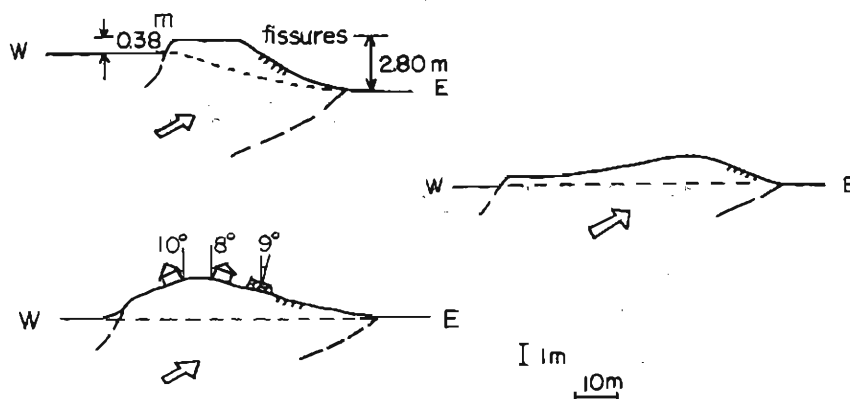
Fig. 16. Mole tracks along the Fukôzu fault in the Mikawa earthquake. (illustrated after Inouye)

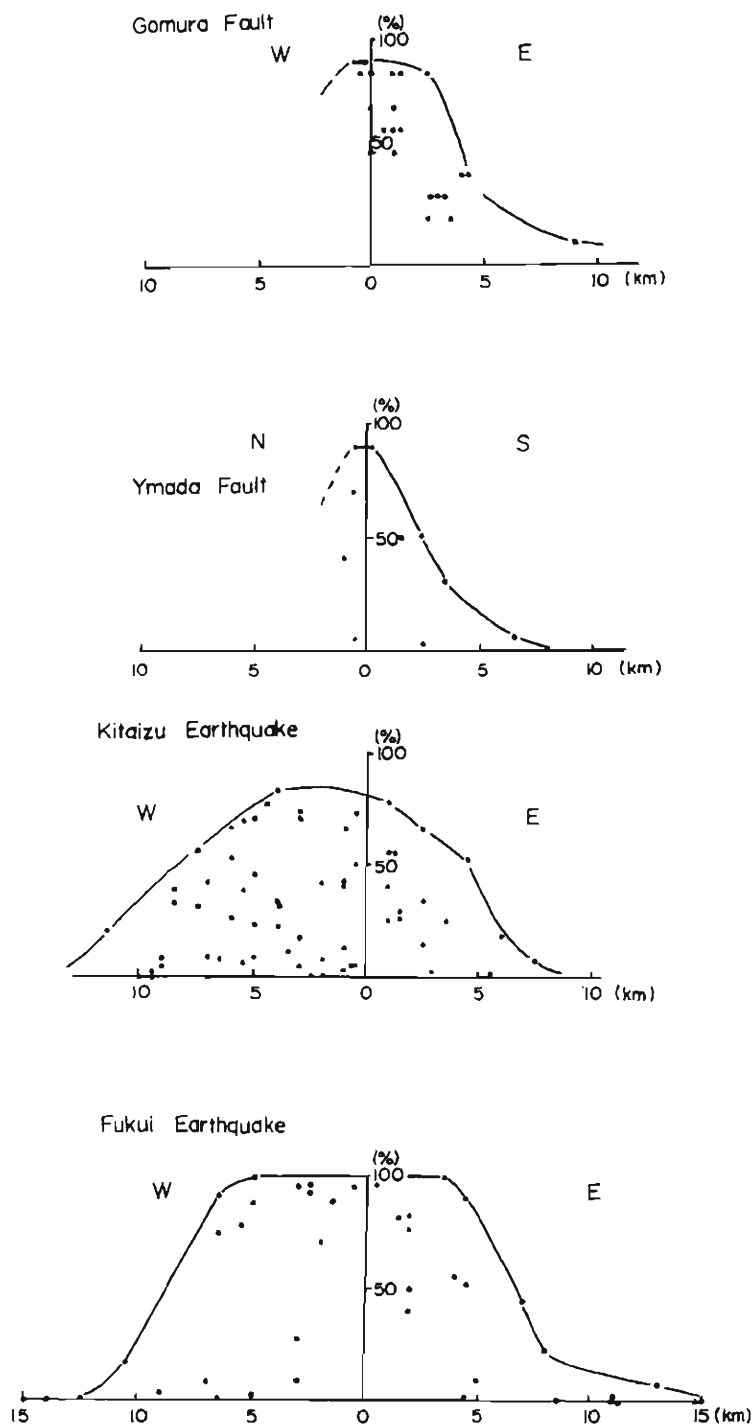
Fig. 17. Percentages of totally collapsed houses versus distance from the fault line in the Tango ($M=7.5$), Kita-Izu ($M=7.0$), and Fukui earthquake ($M=7.3$).

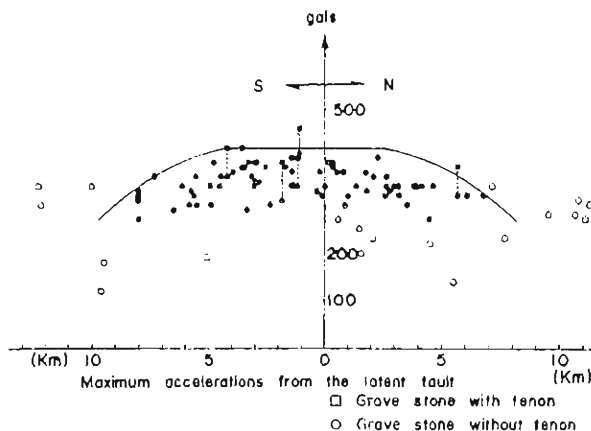
Fig. 18. Maximum accelerations versus distance from the postulated fault line in the Central-Oita earthquake. (reproduced from Omote)

Recently, Omote et al.²⁶⁾ investigated the distribution of overturned gravestones in the Central-Ōita earthquake of M 6.4 and estimated the maximum accelerations versus the distance from the latent fault postulated from the concentration of damage as shown in Fig. 18. In the figure it is evident that the maximum accelerations drop rapidly from about 5 km on. The result seems to meet the experiences described above.

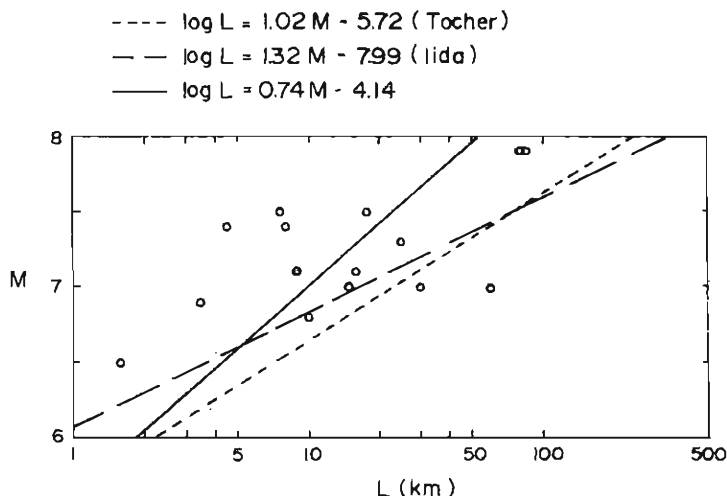
Fig. 19. Earthquake magnitude and the length of fault in the earthquakes given in Table I.

and corresponding lines by Tocher as well as by Iida are also indicated. The last expression is close to the formula proposed quite recently by Matsuda³⁰⁾ giving $L=80$ km at $M=8$ and $L=20$ km at $M=7$;

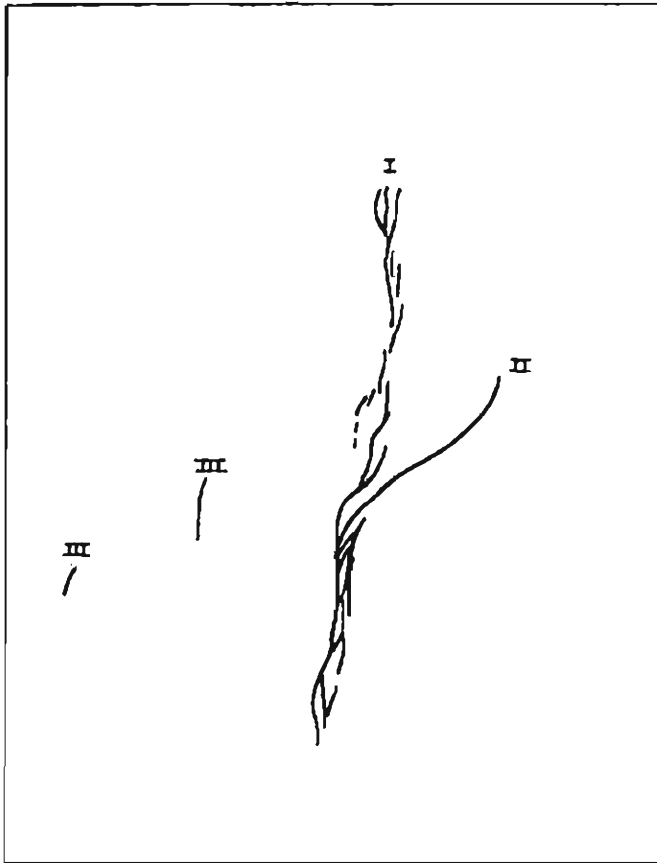
Fig. 20. Diagram showing (I) main fault zone, (II) branch fault, and (III) secondary faults. (reproduced from Bonilla)

Bonilla³¹⁾ classified the earthquake faults into main, branch, and secondary faults, which have been employed in the preceding pages. The classification illustrated in Fig. 20. applies also to Japanese faults in many cases, but it seems not to be very appropriate for cases as the Rikuu, Tajima, Tango, Tottori, and probably the Mikawa earthquakes too, where two faults with dimensions of equal order were formed and it was impossible to judge which was the main. Also in other earthquakes the main fault was in general not a single connected rupture, but several segments en échelon appeared, forming an aggregated main fault system.

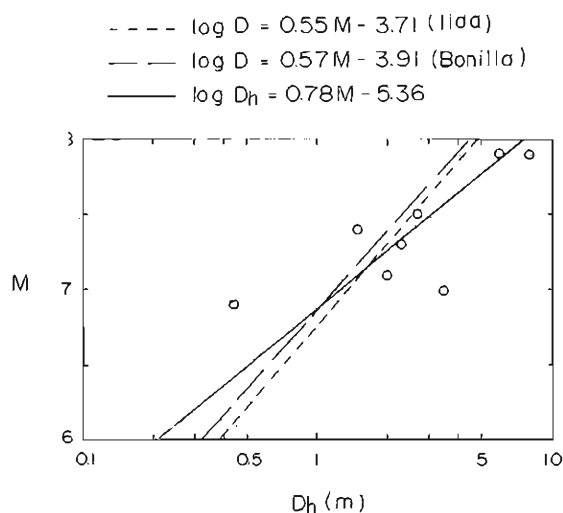
Fig. 21. Earthquake magnitude and the maximum horizontal displacement on fault in the earthquakes given in Table 1.

In hazard assessment the significance of horizontal and vertical displacements are different, and the amounts in the horizontal and vertical directions in Table 1 are plotted separately in Fig. 21 and 22. Empirical equations by the method of least square are

for the horizontal and vertical displacements, respectively. The relations by Iida as well as by Bonilla are also given in the figures.

From Table 1 or Fig. 21 and 22 it is noted that the horizontal displacement is predominant in Japanese faults. The cases $D_h > D_v$ are the Nobi, Kanto, Tango, Kita-Izu, Tottori, Fukui and the off Izu-Peninsula earthquakes, while the cases $D_h < D_v$ are the Shonai, Rikuu, Tajima, and Mikawa earthquakes. In the latter group the result on the Shonai event is unreliable, and moreover also in the Rikuu earthquake, where only the value of D_v is reported, it is not very certain that there was no horizontal displacement, since the horizontal shift is more difficult to determine than the vertical one without detailed survey.

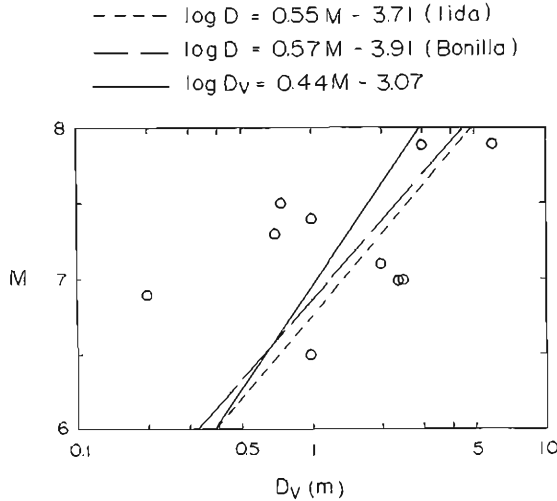
Fig. 22. Earthquake magnitude and the maximum vertical displacement on fault in the earthquakes given in Table 1.

$$\log_{10} D_v(m) = 0.44M - 3.07$$
